Derelict park features

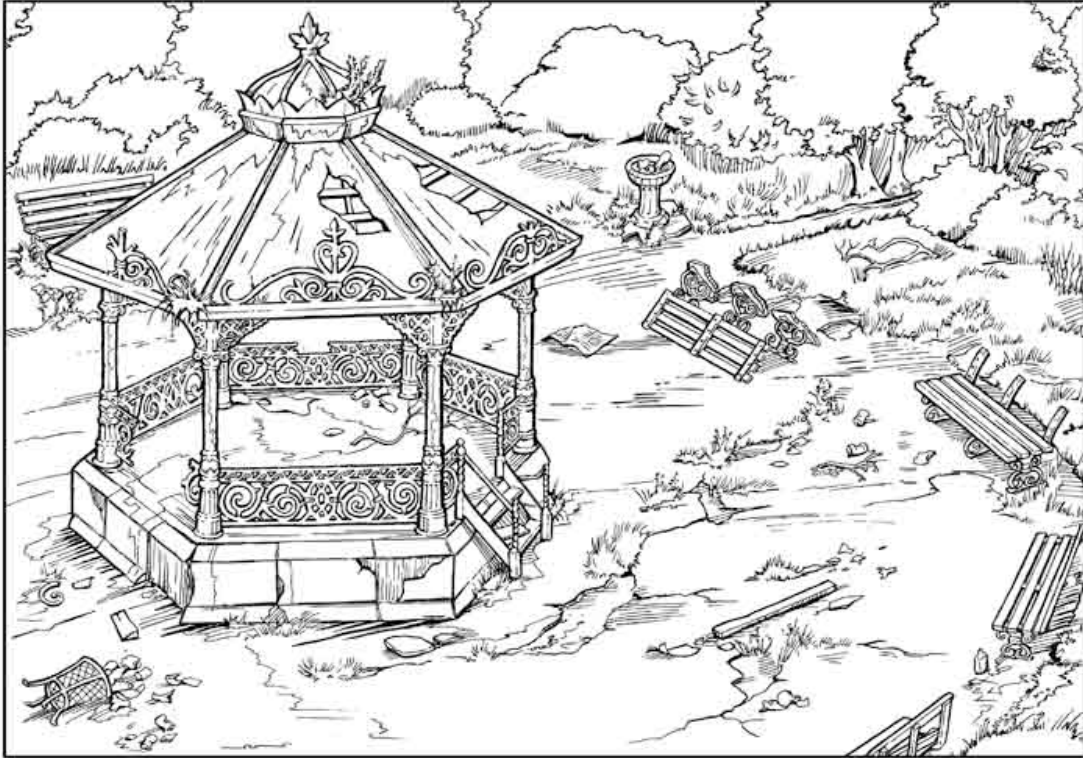
1) Bandstand

The bandstand is structurally sound, but its roof leaks badly. Most of the paintwork on the metalwork has peeled off and the wrought iron is beginning to rust. The concrete base and surrounding area is severely cracked and needs resurfacing.

- Estimated cost to repair bandstand: £20,000.
- Estimated cost to replace ground surface: £10,000 - £50,000 depending upon material used.
